DEPARTMENT OF TRANSPORTATION

Contract #: 04-0120F4Cty: SF/ALA Rte: 80 PM: 13.2/13.9File #: 99.28**WELDING INSPECTION REPORT****Resident Engineer:**Siegenthaler, Peter**Address:** 333 Burma Road**City:** Oakland, CA 94607**Report No:** WIR-019009**Date Inspected:** 31-Dec-2010**Project Name:** SAS Superstructure**OSM Arrival Time:** 700**Prime Contractor:** American Bridge/Fluor Enterprises, a JV**OSM Departure Time:** 1900**Contractor:** Zhenhua Port Machinery Company, Ltd (ZPMC)**Location:** Shanghai, China**CWI Name:** Li Yang and Zhu Zhong Hai**CWI Present:** Yes No**Inspected CWI report:** Yes No N/A**Rod Oven in Use:** Yes No N/A**Electrode to specification:** Yes No N/A**Weld Procedures Followed:** Yes No N/A**Qualified Welders:** Yes No N/A**Verified Joint Fit-up:** Yes No N/A**Approved Drawings:** Yes No N/A**Approved WPS:** Yes No N/A**Delayed / Cancelled:** Yes No N/A**Bridge No:** 34-0006**Component:** OBG Trial Assembly**Summary of Items Observed:**

WELDING INSPECTION REPORT

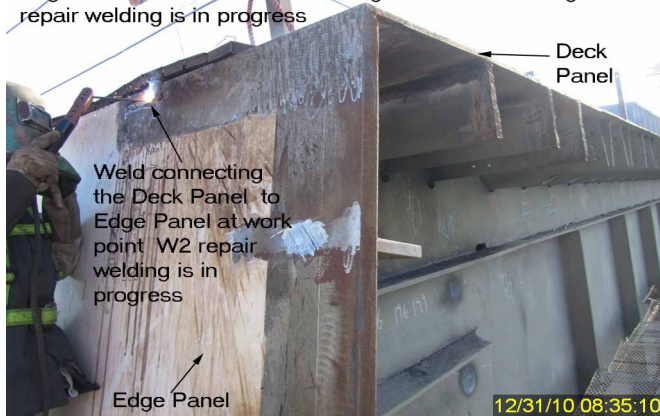
Joint Penetration (CJP) groove weld. The Weld joint was designated as CA3006-002. The welder identification was 040656 and was observed welding in the 4G (Overhead) position using approved Welding Procedure Specification WPS-345-SMAW-4G(4F)-FCM-Repair-1. The piece mark was identified as Deck Panel to Edge Panel hold back weld at work point W2. ZPMC performed repair welding in accordance with Welding Repair Report B-WR19699 dated Dec 28, 2010.

Segment 12AW, Deck Panel to Edge Panel connecting weld repair welding is in progress

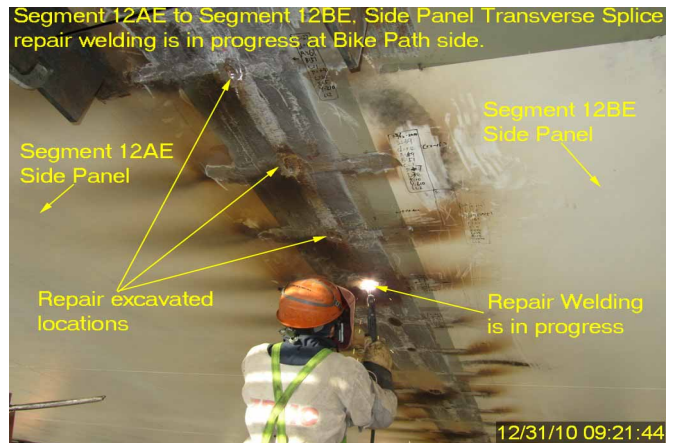
This QA Inspector observed the repair welding by Shielded Metal Arc Welding (SMAW) process on a Complete Joint Penetration (CJP) groove weld. The Weld joint was designated as OBE12D-003. The welder identification was 044515 and observed welding in the 4G (Overhead) position using approved Welding Procedure Specification WPS-345-SMAW-4G(4F)-FCM-Repair-1. The piece mark was identified as the Side Panel, at transverse splice at Bike Path side. ZPMC performed repair welding in accordance with Welding Repair Report B-WR-19715 dated Dec 28, 2010.

Segment 12AE to Segment 12BE, Side Panel Transverse Splice repair welding is in progress at Bike Path side.

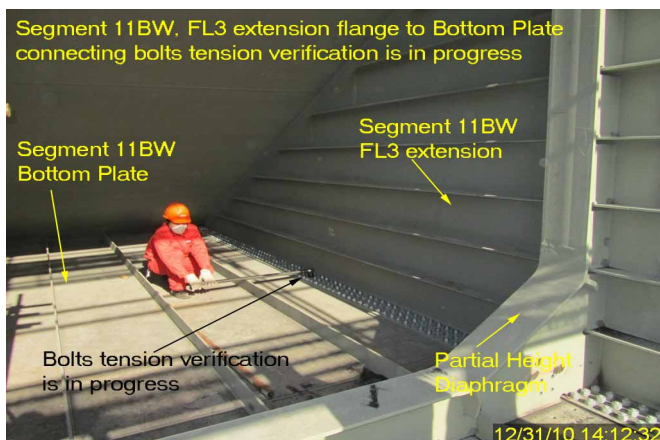
This QA Inspector witnessed the final bolt tension verification on bolts connecting the Bottom Plate to FL3 Flange and Bottom Panel to Bottom Plate at Panel Points (PP) 98, PP 99 and PP 100 for Segment 11BW. The QA Inspector verified the bolt tension on a random basis and the results appeared to be in general compliance. The Inspection was performed against Notification No. 00588.

Segment 11BW, FL3 extension flange to Bottom Plate connecting bolts tension verification is in progress

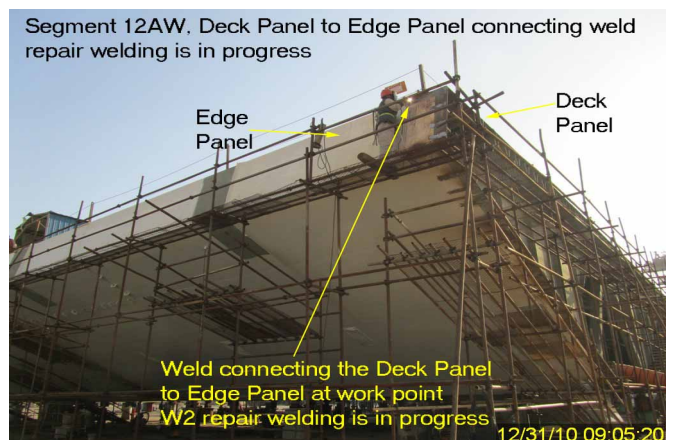
Segment 12AW, Deck Panel to Edge Panel connecting weld repair welding is in progress
